**National Highway
Traffic Safety
Administration**

Case Vehicle (A): 1999 Dodge
Type: Ram 2500 Laramie SLT 4 x 4, Quad cab pickup
with trailer
Driver: 40-year-old male
CDC: 12-FDEW-1

Veh. (B): 1999 Ford
Type: Escort ZX2, 2-door coupe
Driver: 18-year-old male
CDC: 02-RZAW-3

SITUATION

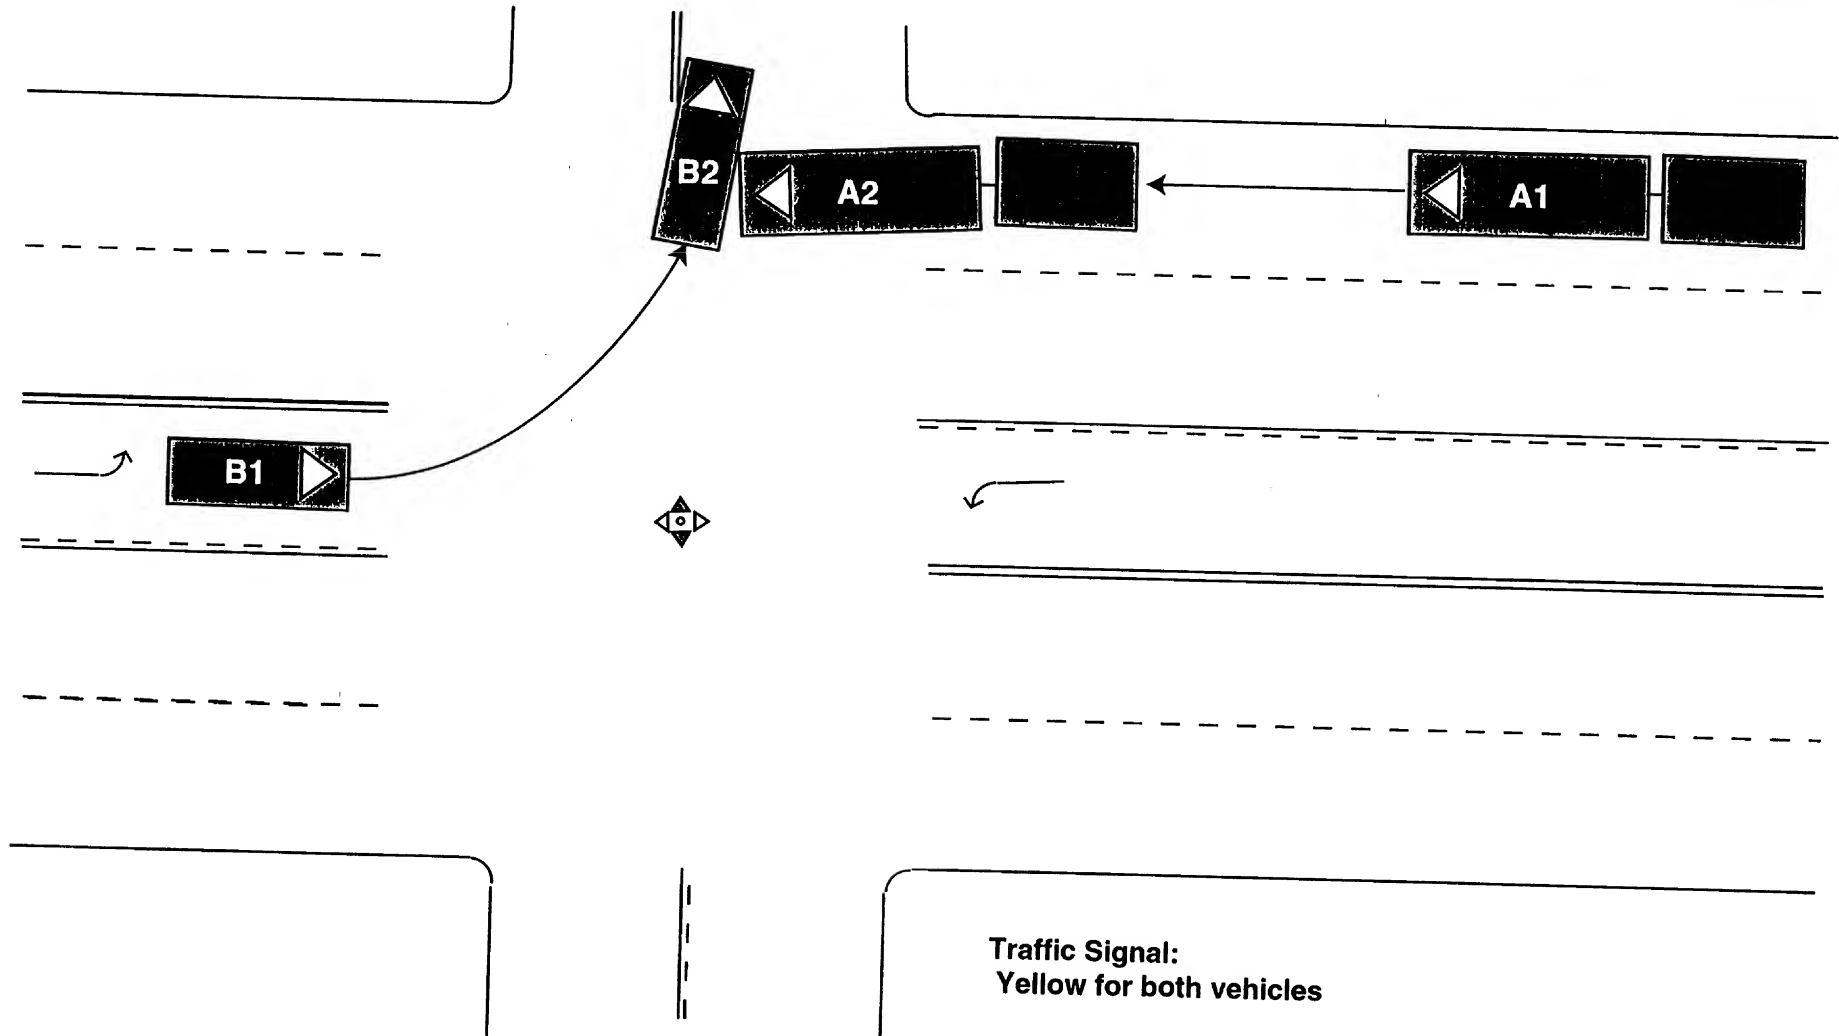
ACCIDENT SCHEMATIC

ACCIDENT DESCRIPTION: Case vehicle (A) was traveling west
when vehicle (B) turned into its path. Case vehicle
(A) was unable to stop in time and struck the
right side of vehicle (B) with its front.

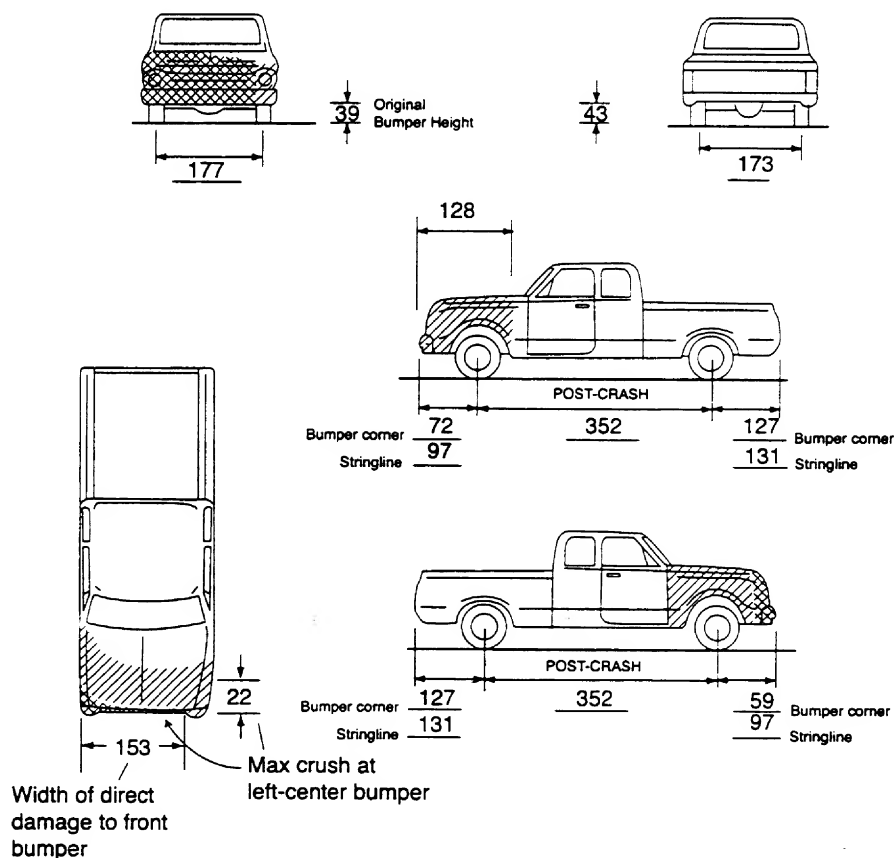
VEHICLE DAMAGE

Direct Damage Length (DDL) 1 5 3 cm

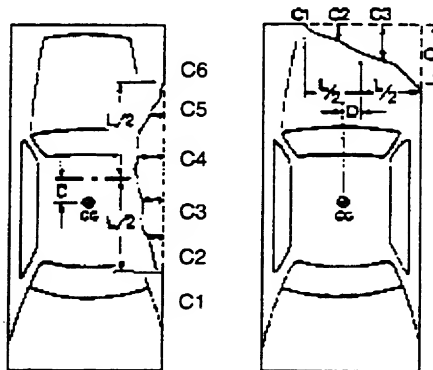
Specific Impact No.	Location of Direct Damage	Location of Field L
<u>1</u>	<u>Begin 27cm Rt of Lt Ft BC</u>	<u>Ft Bumper BC to BC</u>

DL 153UDL 27

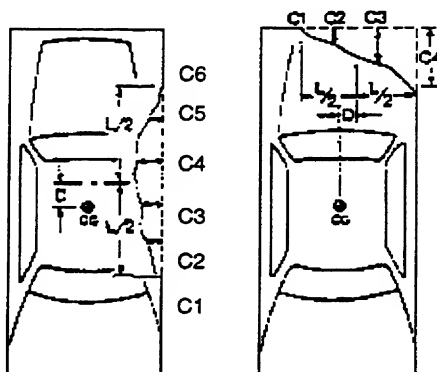
Specific Impact No.	Location of Direct Damage	Location of Field L
1	103cm Rear of Rt Ft Axle	94cm rear of Rt Ft Axle

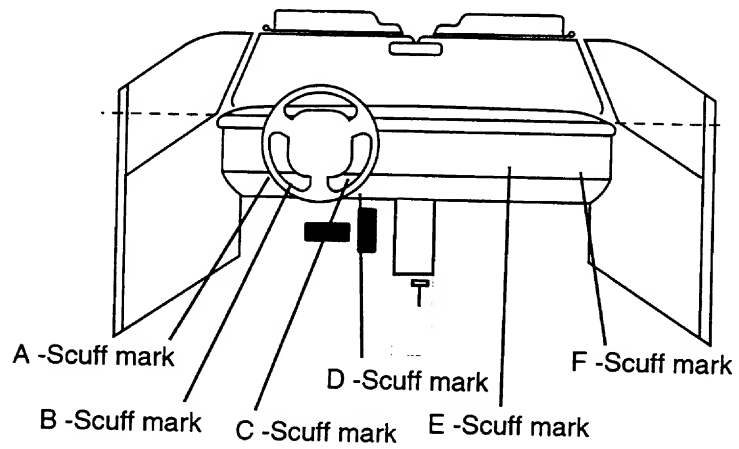
VEHICLE OCCUPANT CONTACT DIAGRAM

Contact	Interior Component Contacted	Occupant No. if Known	Body Region if Known	Supporting Physical Evidence	Confidence Level of Contact Point
A	Knee bolster	Driver	Lt. leg	Scuff mark	1
B	Knee bolster	Driver	Lt. leg	Scuff mark	1
C	Knee bolster	Driver	Rt. leg	Scuff mark	1
D	Knee bolster	Driver	Rt. leg	Scuff mark	1
E	Glove box	Right front	Lt. knee	Scuff mark	1
F	Glove box	Right front	Rt. knee	Scuff mark	1
G					
H					
I					
J					
K					
L					
M

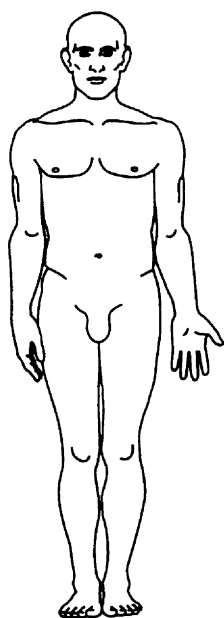
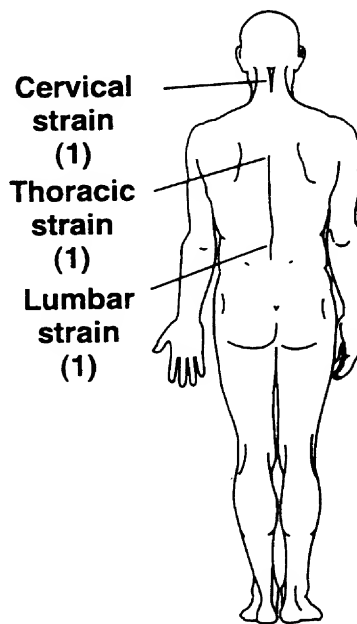
INDICATE LOCATION OF INJURIES.

Cervical
strain
(1)
Thoracic
strain
(1)
Lumbar
strain
(1)
